# COMPARISON OF NEW AND OLD **HIGH VOLTAGE** **DIAMOND COIL** ELECTRICAL INSULATION PERFORMANCE FOR HYDROELECTRIC GENERATORS

This paper compares high-voltage electrical coils from hydroelectric generators after 38 years of service with newly manufactured replacement coils. The original coils are part of the US Army Corps of Engineers' renovation of the Chief Joseph Dam in Washington State, with 16 generator units (92,920 kVA, 13,800 V) being rewound. Preformed Windings will supply the new coils, designed to sustain decades of renewable energy production. With the average age of hydroelectric power stations in the U.S. approaching 50 years, this paper serves as a reference for the industry of the expected benefits that can be achieved by rewinding of the fleet using resin rich coils manufactured with modern techniques.

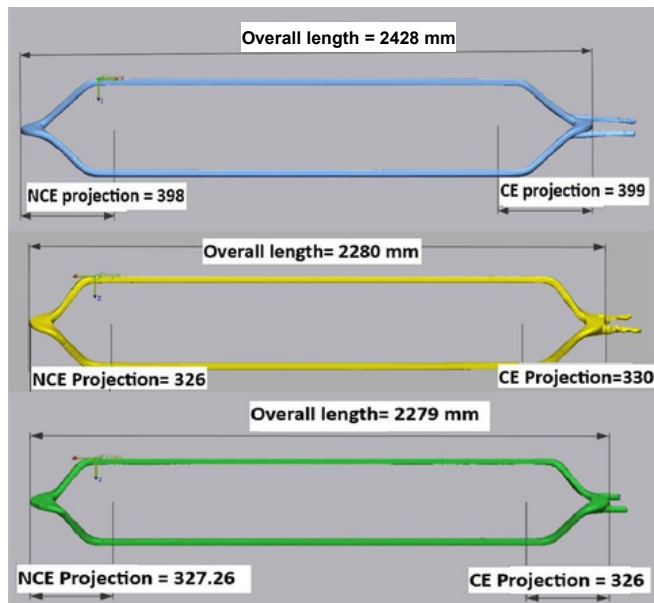
The GEN and STORE coils were scanned and compared to the NEW coils to see any differences in the design. Figure 1 shows clearly that the NEW coil has longer projections compared to the original coil sets. It will provide a marginally increased coil resistance. The NEW coils are longer at 2428mm compared to 2280mm for the original coil sets.

Fig. 1. Comparison of the overall dimensions of the original and new coil sets from laser scans, Top – NEW, middle – GEN, bottom – STORE.

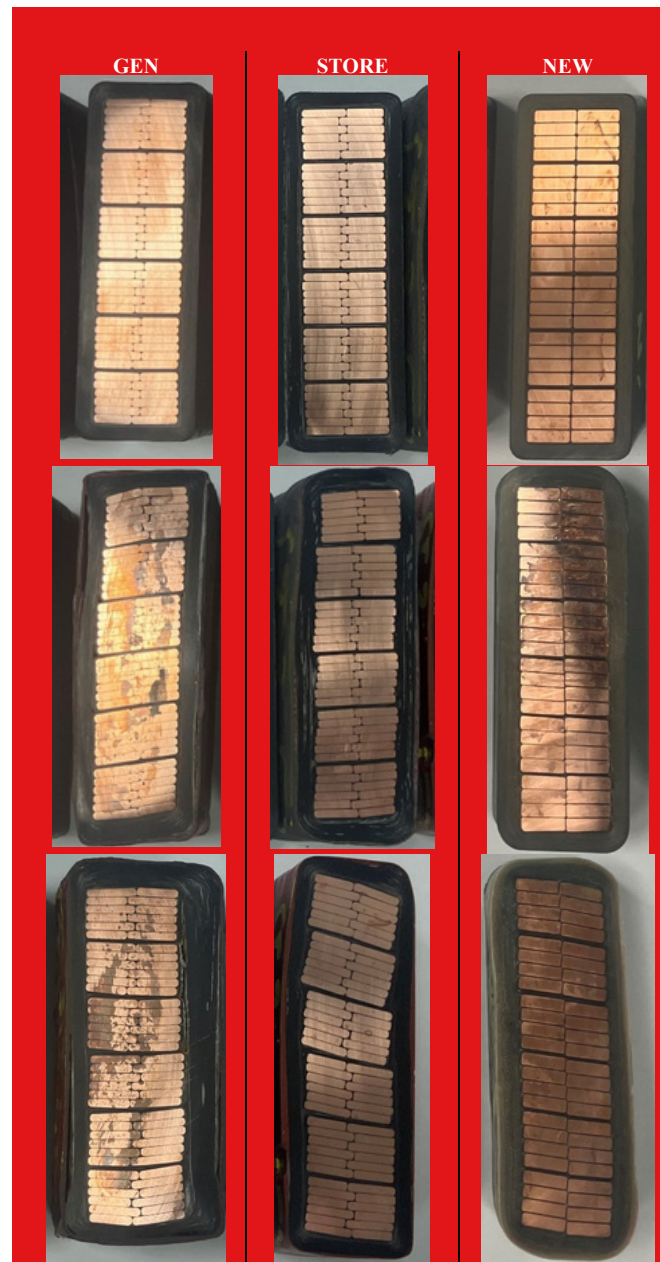
Two coils were chosen for dissection one from the generator (GEN3 – due to failure), and one from storage coils (STORE 3). These dissections are compared to the new coil dissection done during the qualification stage of the coil development at Preformed Windings, as shown in Figure 2.

The straight sections of the coils have a good uniform structure and are very comparable to the NEW coil set in terms of uniformity of the copper strands and the insulation of the ground wall is uniform in thickness and has minimal void content to the naked eye.

The stress grading dissection cuts show misalignment in the conductors on all coil sets, however the NEW coil has significantly improved copper strand alignment. Also, the level of insulation is more evenly distributed around the circumference of the conductors. The original coil sets show a significant delamination and void content within the stress grading sections, the impact of which will be discussed in more detail further in the paper.

Fig. 2. Dissections of the three coil groups, Top – straight leg portion, Middle – Stress grading region (around the first bend), Bottom – beyond stress grading region.

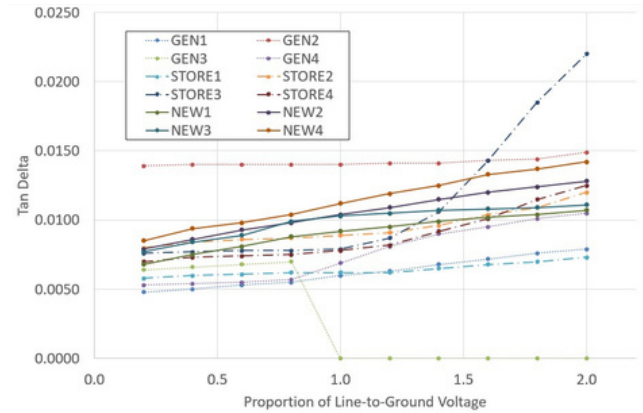
The results indicate that all groups of coils have good tan-delta measurements relative to the standards applied in [2] apart from STORE3 which has failed on the power factor tip-up specification between  $(2U_n - 1.2U_n)$ . Coil GEN3 failed during testing at 7.95kV.

Overall, no conclusion can be drawn from the effect of aging on tan delta of dissipation factor, or on the comparison with the NEW coils, apart from the NEW coils have a narrower distribution on the results.

Fig. 3 Dissipation factor measurements on the coils sets.

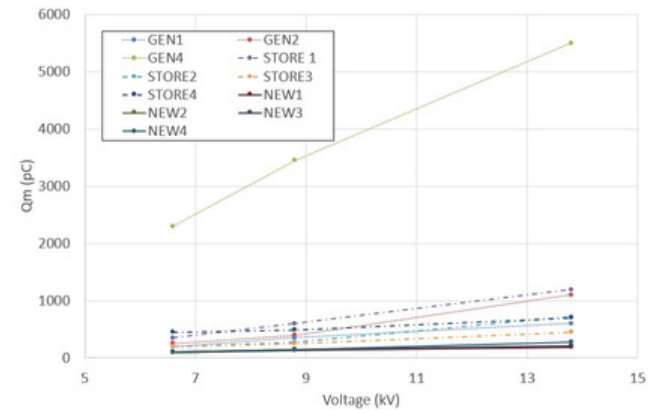
a) Including GEN 4

Fig. 4. Partial discharge measurements across different voltage ranges for 3 different coil groups.

The partial discharge was measured on all 3 coil groups to see the impact of in-service lifetime between the GEN and STORE coils. Figure 4 a) shows the measured values of the coils groups including coil GEN4 which has high levels of PD across the range.

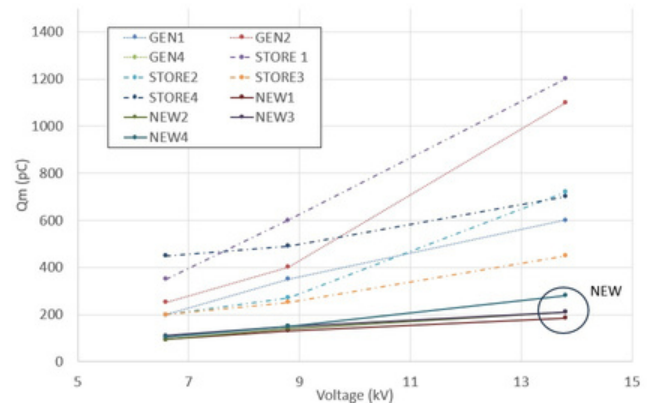
b) Excluding GEN 4 to give better resolution for the remaining measurements

If we exclude GEN4, then we can see in Figure 4 b) the values of PD between the GEN and STORE coil groups are similar with GEN1 coil giving remarkable results considering the lifetime. The distribution of the coil measurements suggests that the stored coils already have a significant variance prior to installation of the coils which could result in specific coils undergoing more rapid aging due to the higher initial levels of PD as seen on GEN4.

The NEW group of coils shows reduced levels of PD across the range of voltage measurements and have a far narrower distribution of values. This suggests that an improved manufacturing process allowing for greater control of variance over the whole set of coils, this in turn can improve the overall lifetime of the generator coil sets.

The increased PD in the original coil groups can be attributed to the higher levels of voids and delamination witnessed in the ground wall insulation of the coil in the stress grading area and beyond.

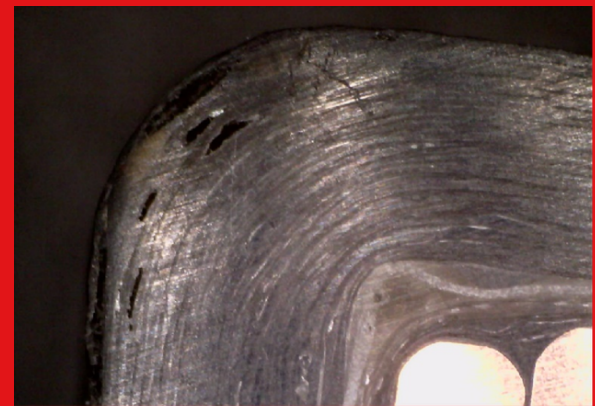
a) GEN 3 – Bottom Leg Middle

Given the differences in the PD levels between the original coil groups and the NEW coils it was decided to review the coil dissections in detail under a microscope. The purpose is to compare the finish quality of the ground wall insulation in order to understand the differences between the coil groups. The straight section of the coils were reviewed under the microscope and highlighted significant voids and delamination which was prevalent in all cross-sectional cuts from the original coil sets (both GEN and STORE). Figure 5 shows images of the delamination which were measured in the region of 0.15mm (0.006 inch) in the radial direction. The small voids were present in all corners of the slot section dissections from the original coil sets, which would contribute to increased partial discharge levels when compared to the NEW coils.

Fig. 5. Microscope image of coil insulation cross section.
